**FLOOD PLAIN INFORMATION  
CUYAHOGA RIVER  
FRANKLIN TWP  
CITY OF STREETSBORO  
AND SHALERSVILLE TWP  
PORTAGE COUNTY  
OHIO**

**CORPS OF ENGINEERS, U.S. ARMY  
BUFFALO DISTRICT**

**JUNE 1974**

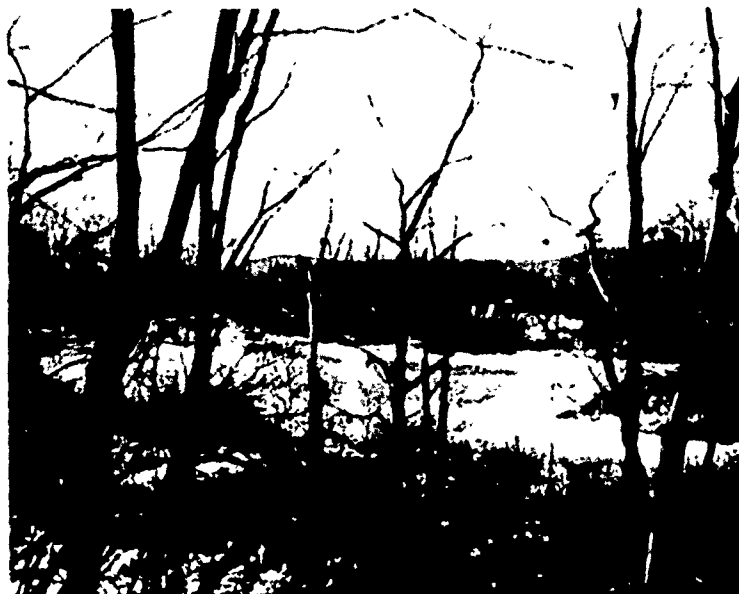
**FIGURE 3 —** Looking downstream at small trees on overbank at river mile 61.65.

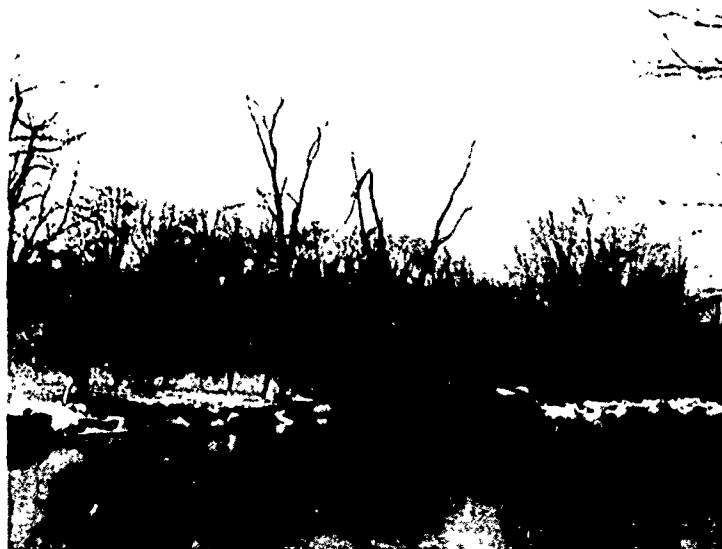
**FIGURE 4 —** Looking upstream at densely wooded island and northwest bank at river mile 62.00.

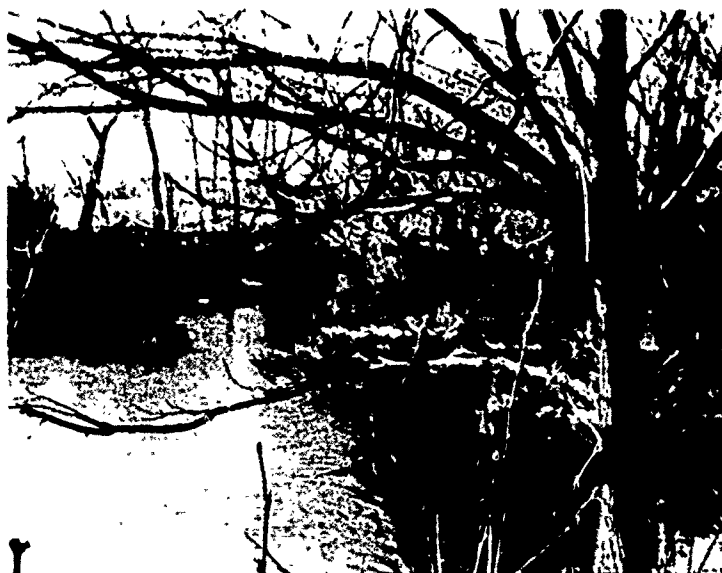
**FIGURE 5 —** Wooded banks and island at river mile 62.35.

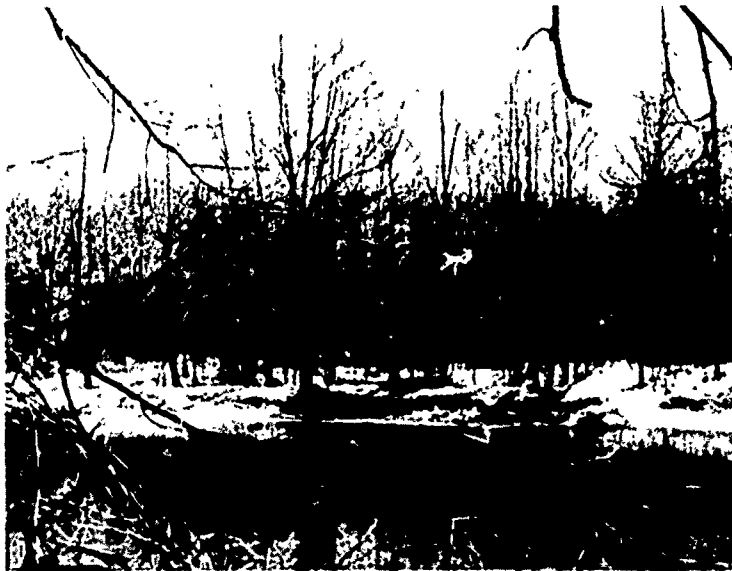
**FIGURE 6 — Looking downstream at southeast overbank at river mile 62.83.**

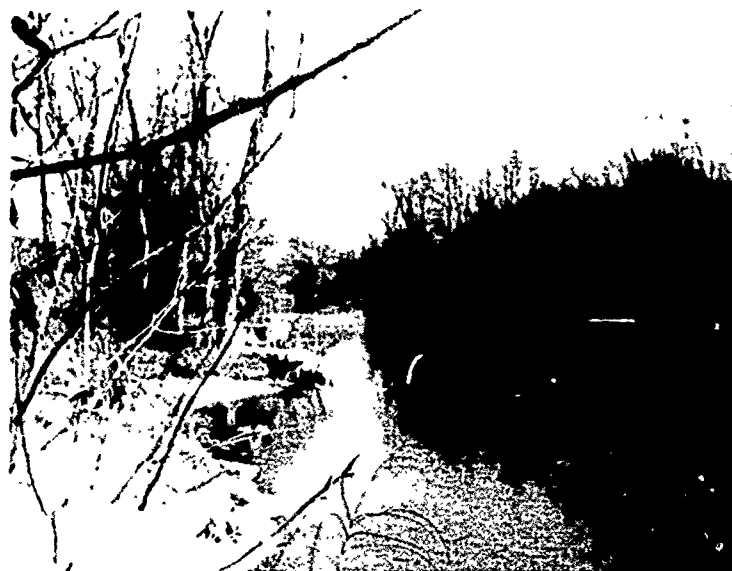
**FIGURE 7 — View of wooded banks looking upstream at river mile 62.94.**

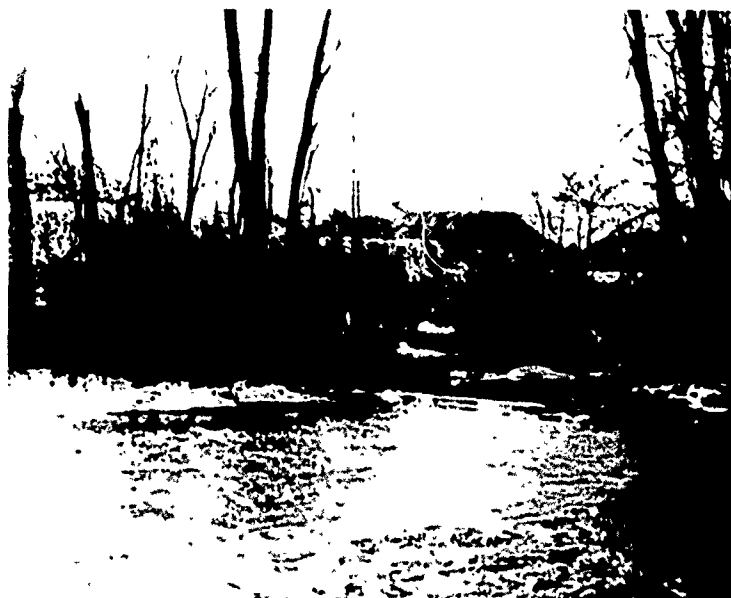
**FIGURE 8** — Partially clogged channel with wooded and brush covered banks at river mile 64.14.

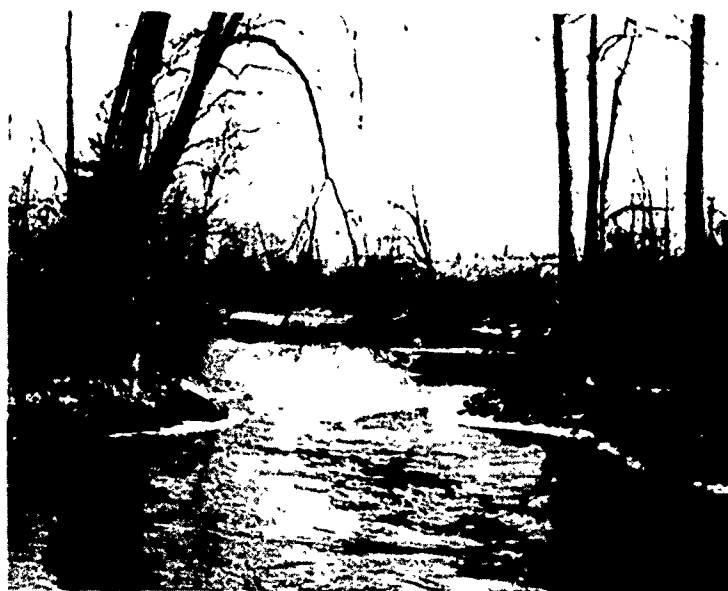
**FIGURE 9** — Looking upstream at narrow channel around island at river mile 64.14.

**Shalersville Township** begins at river mile 63.8 and continues to the end of the study area at river mile 68.75. At the downstream end of this reach is a sand and gravel pit which can be seen in the background of Figure 8. Constriction of the river is caused by several islands as shown in Figures 9 and 10.

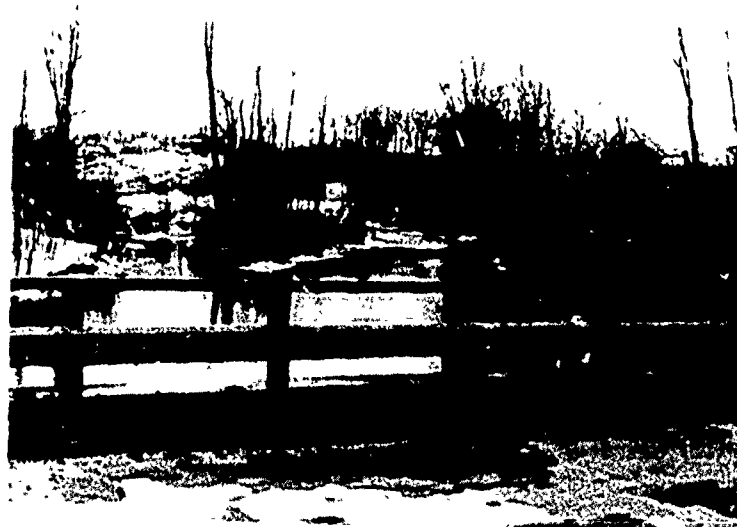
**FIGURE 10** — View looking downstream from Route 303 bridge at river mile 64.55.

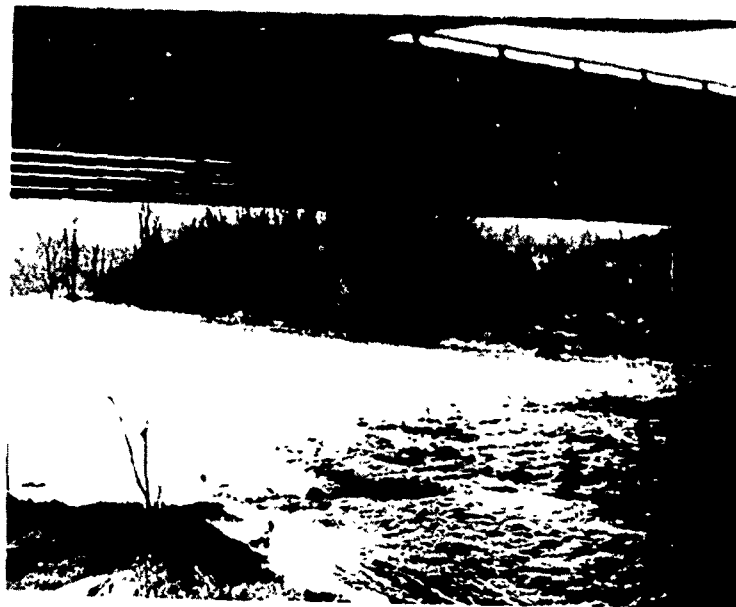
**FIGURE 11** — Looking downstream from Ohio Turnpike bridge at river mile 64.79.

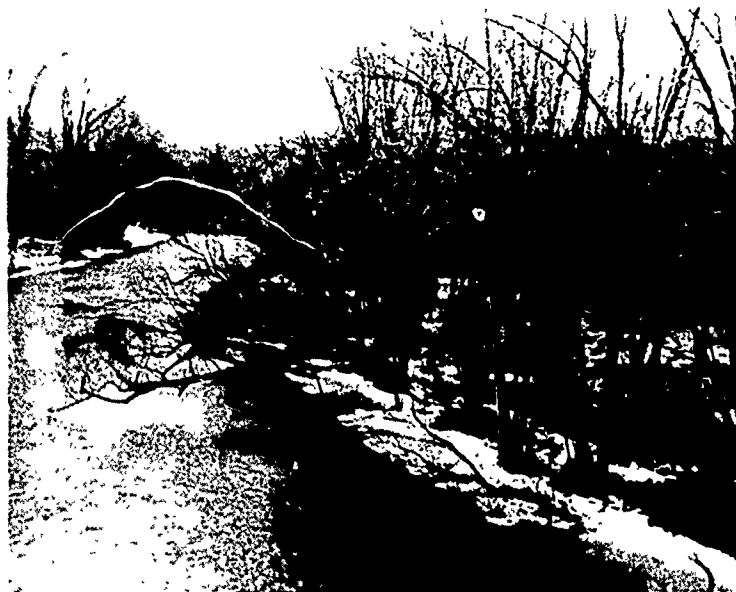
**FIGURE 12** — View from Coit Road bridge looking downstream at river mile 65.64.

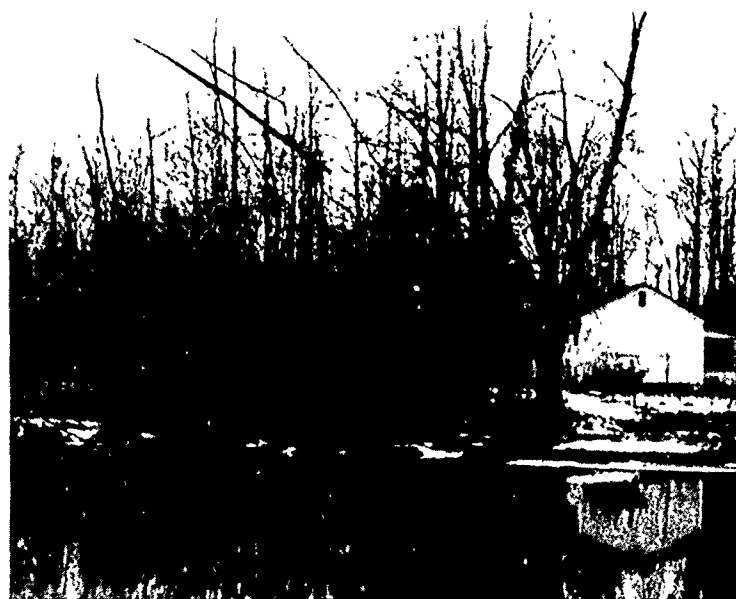
**FIGURE 13** — View of wooded bank and overbank looking downstream at river mile 66.59.

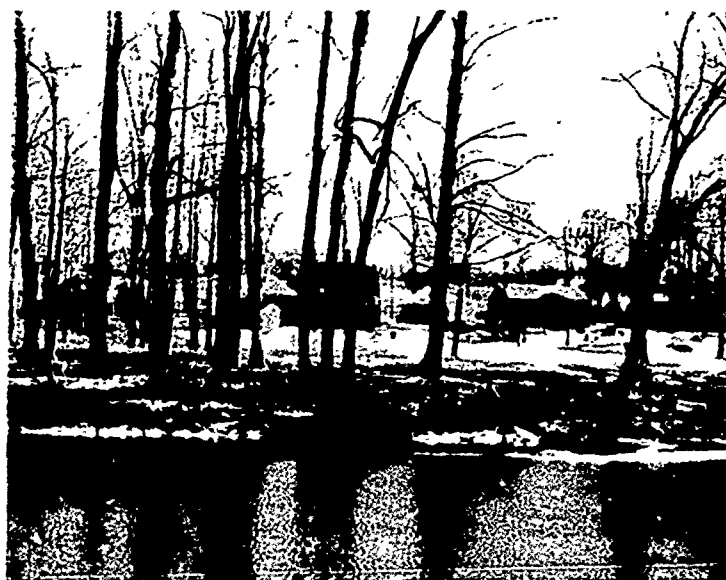
**FIGURE 14** — Looking southeast at river mile 67.59.

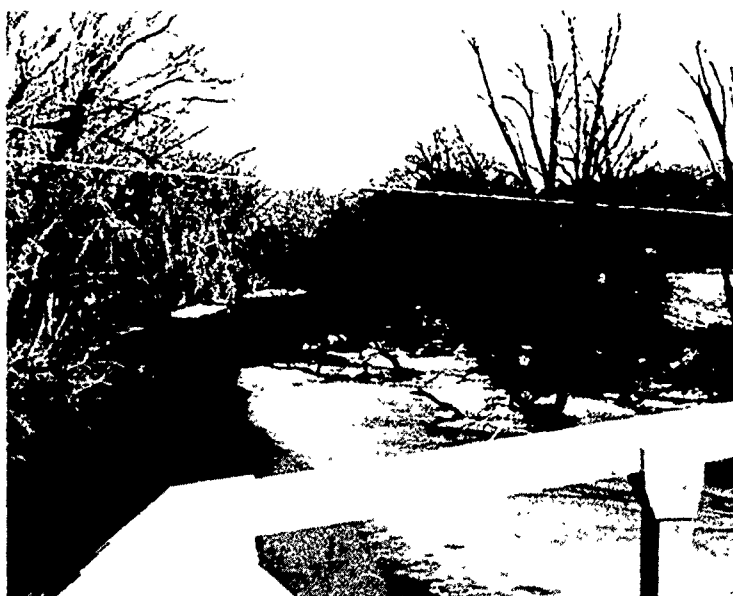
**FIGURE 15** — Fallen trees along bank downstream of Infirmary Road bridge at river mile 67.72.

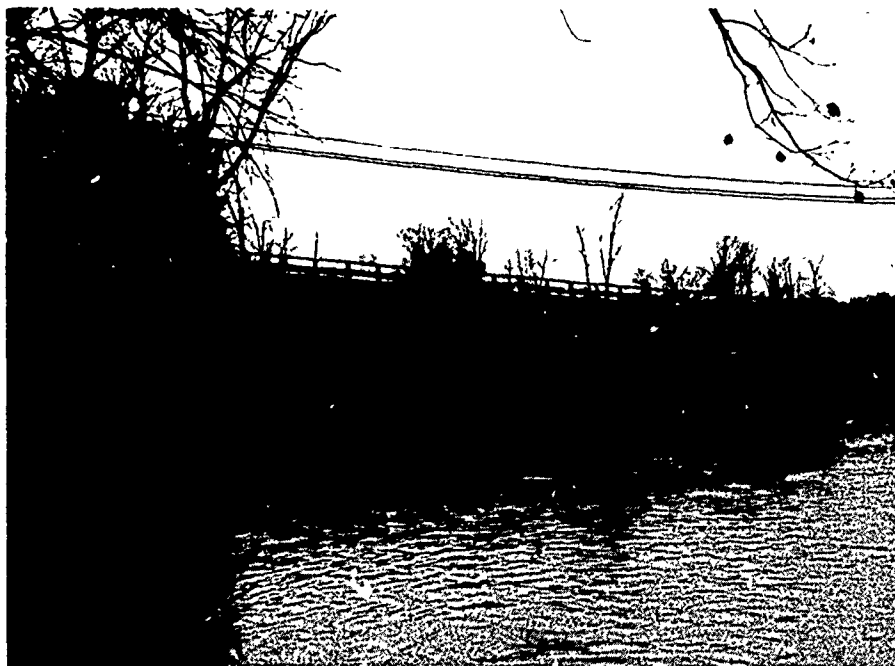
**FIGURE 17** — Route 303 bridge at river mile 64.55 looking downstream at upstream face.

Five bridges cross the Cuyahoga River in the study area. Figures 16 through 20 show these bridges and Table 2 lists a comparison of pertinent bridge structure elevations to the Intermediate Regional Flood and Standard Project Flood elevations.

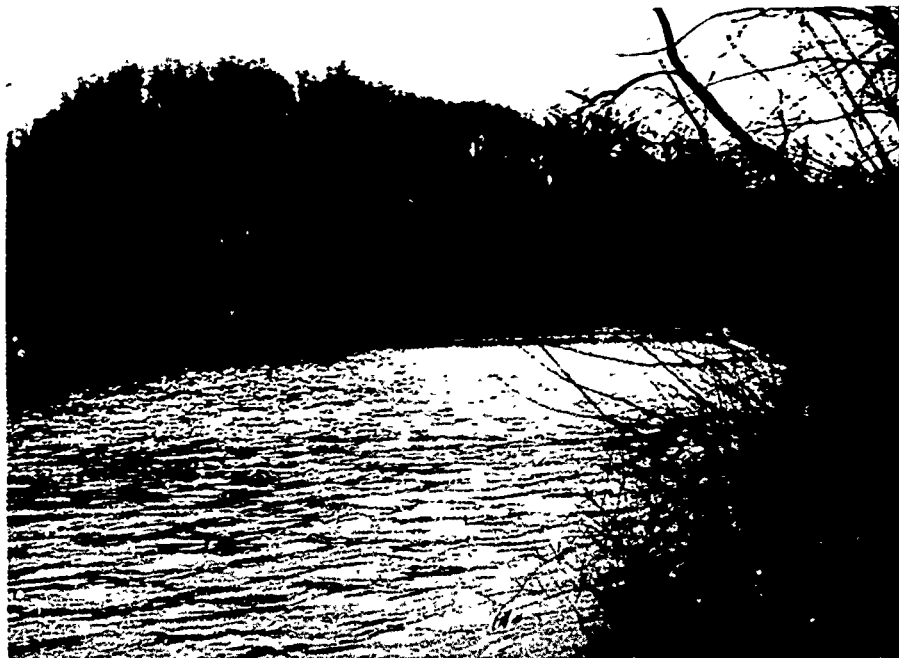
**FIGURE 18** — Ohio Turnpike bridge at river mile 64.78, looking upstream at downstream face.

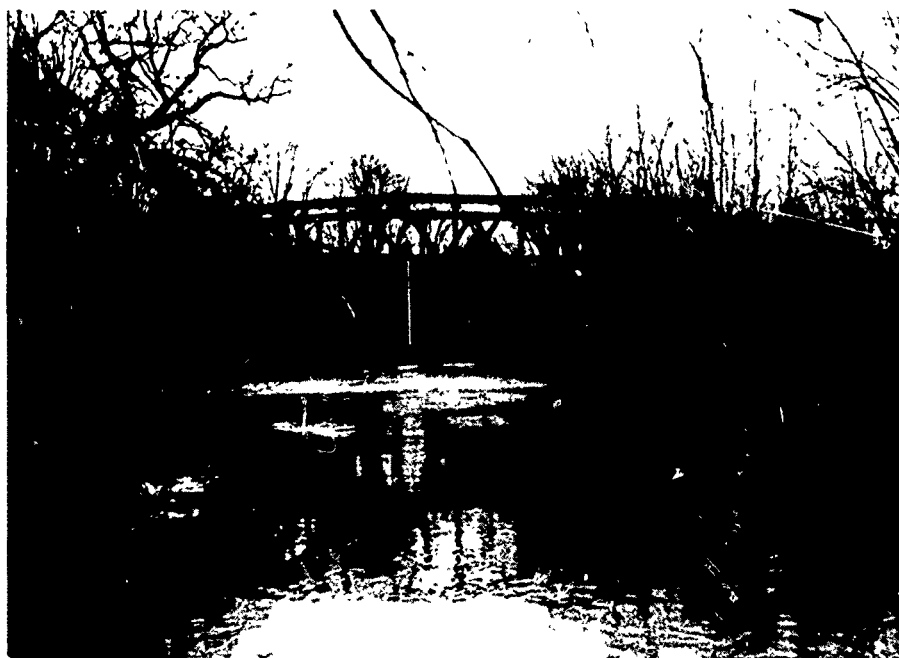
**FIGURE 19** — Coit Road bridge at river mile 65.64 looking downstream at upstream face.

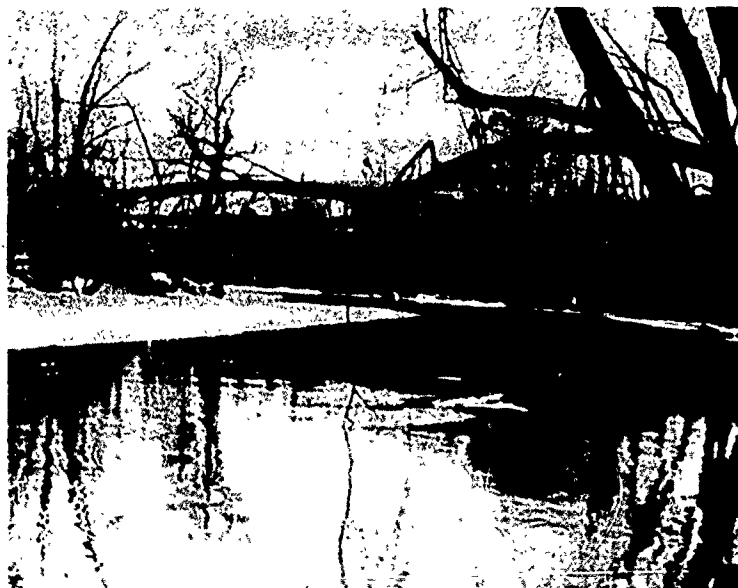
**FIGURE 20** — Infirmary Road bridge at river mile 67.72 looking downstream at upstream face.

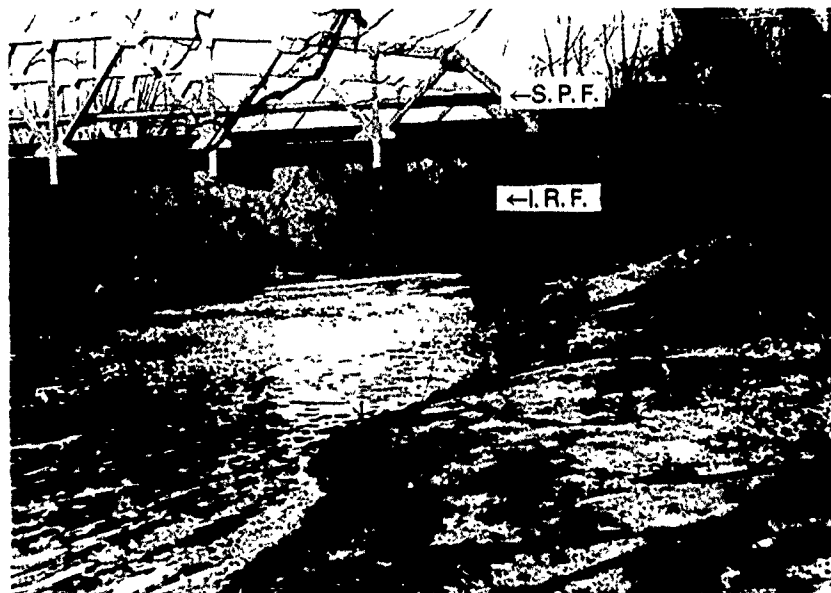
**FIGURE 23** — Heights of flooding are shown by the arrows for the Standard Project Flood and Intermediate Regional Flood on Coit Road bridge at river mile 65.64.

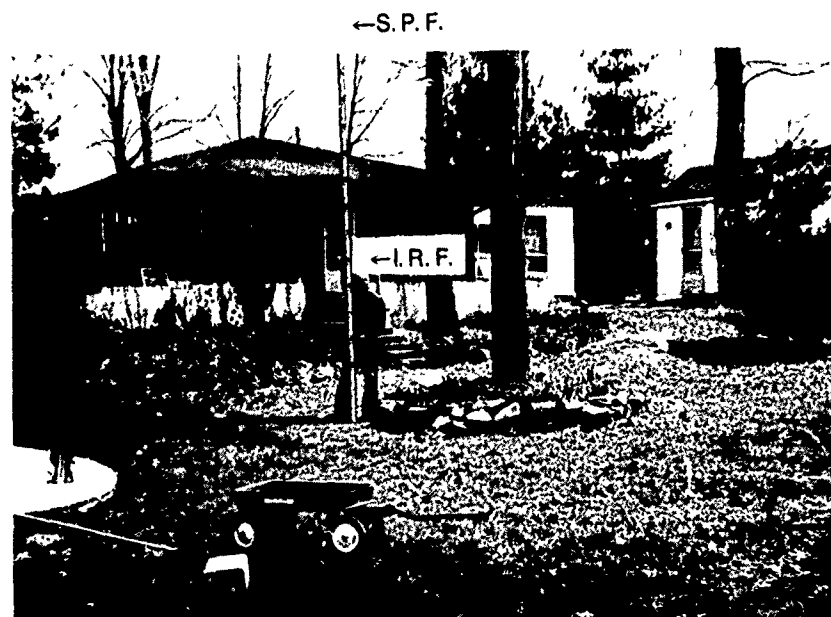
**FIGURE 24** — Heights of the Standard Project and Intermediate Regional Floods are shown by the arrows on this home on Infirmary Road at river mile 67.6.
